GREAT NEAPOLITAN EARTHQUAKE OF 1857.

OBSERVATIONAL SEISMOLOGY

TO INVESTIGATE THE CIRCUMSTANCES OF THE GREAT
EARTHQUAKE OF DECEMBER 1857.

ROBERT MALLET, C.E., F.R.S., F.G.S., M.R.I.A.,
&c., &c.

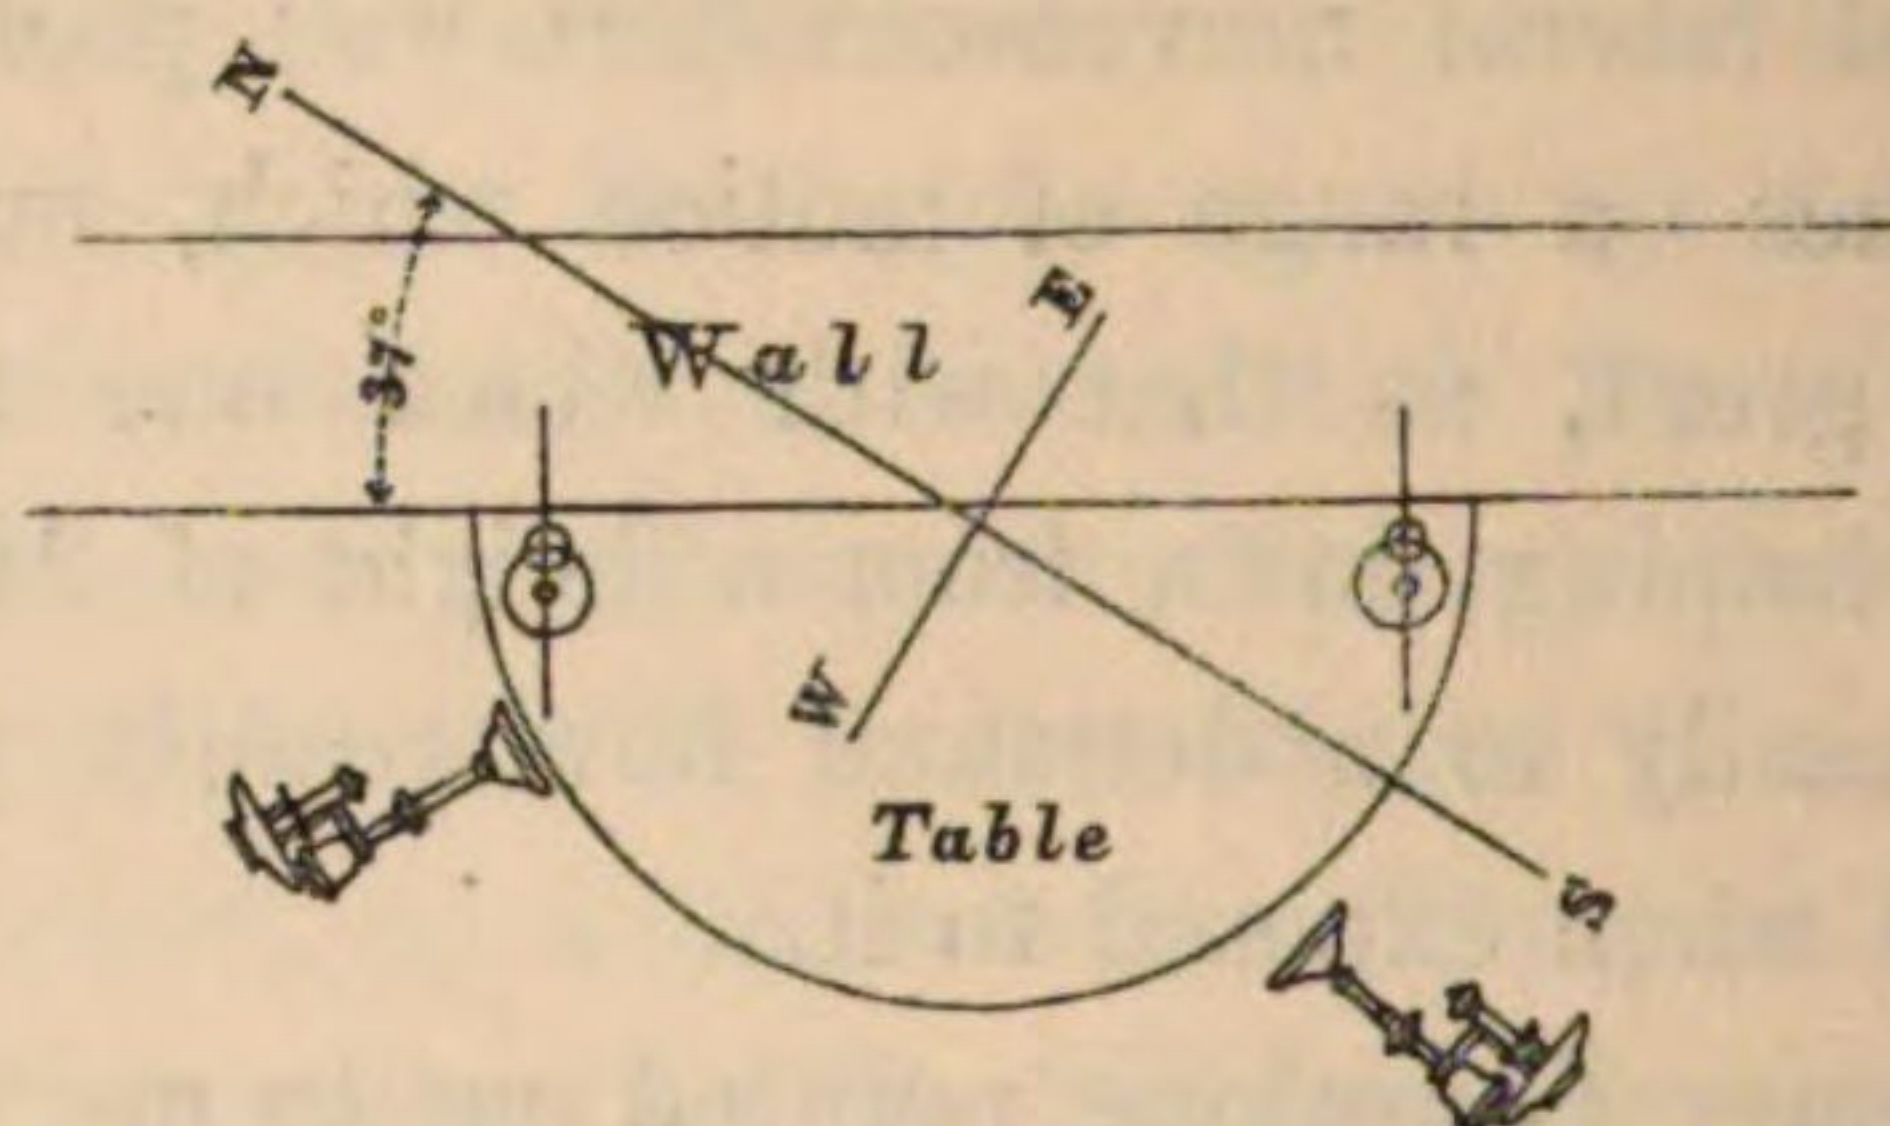
Fig. 204.

normal to the face of the wall, the position of the lamps indicates a wave-path, about 157° W. of north.

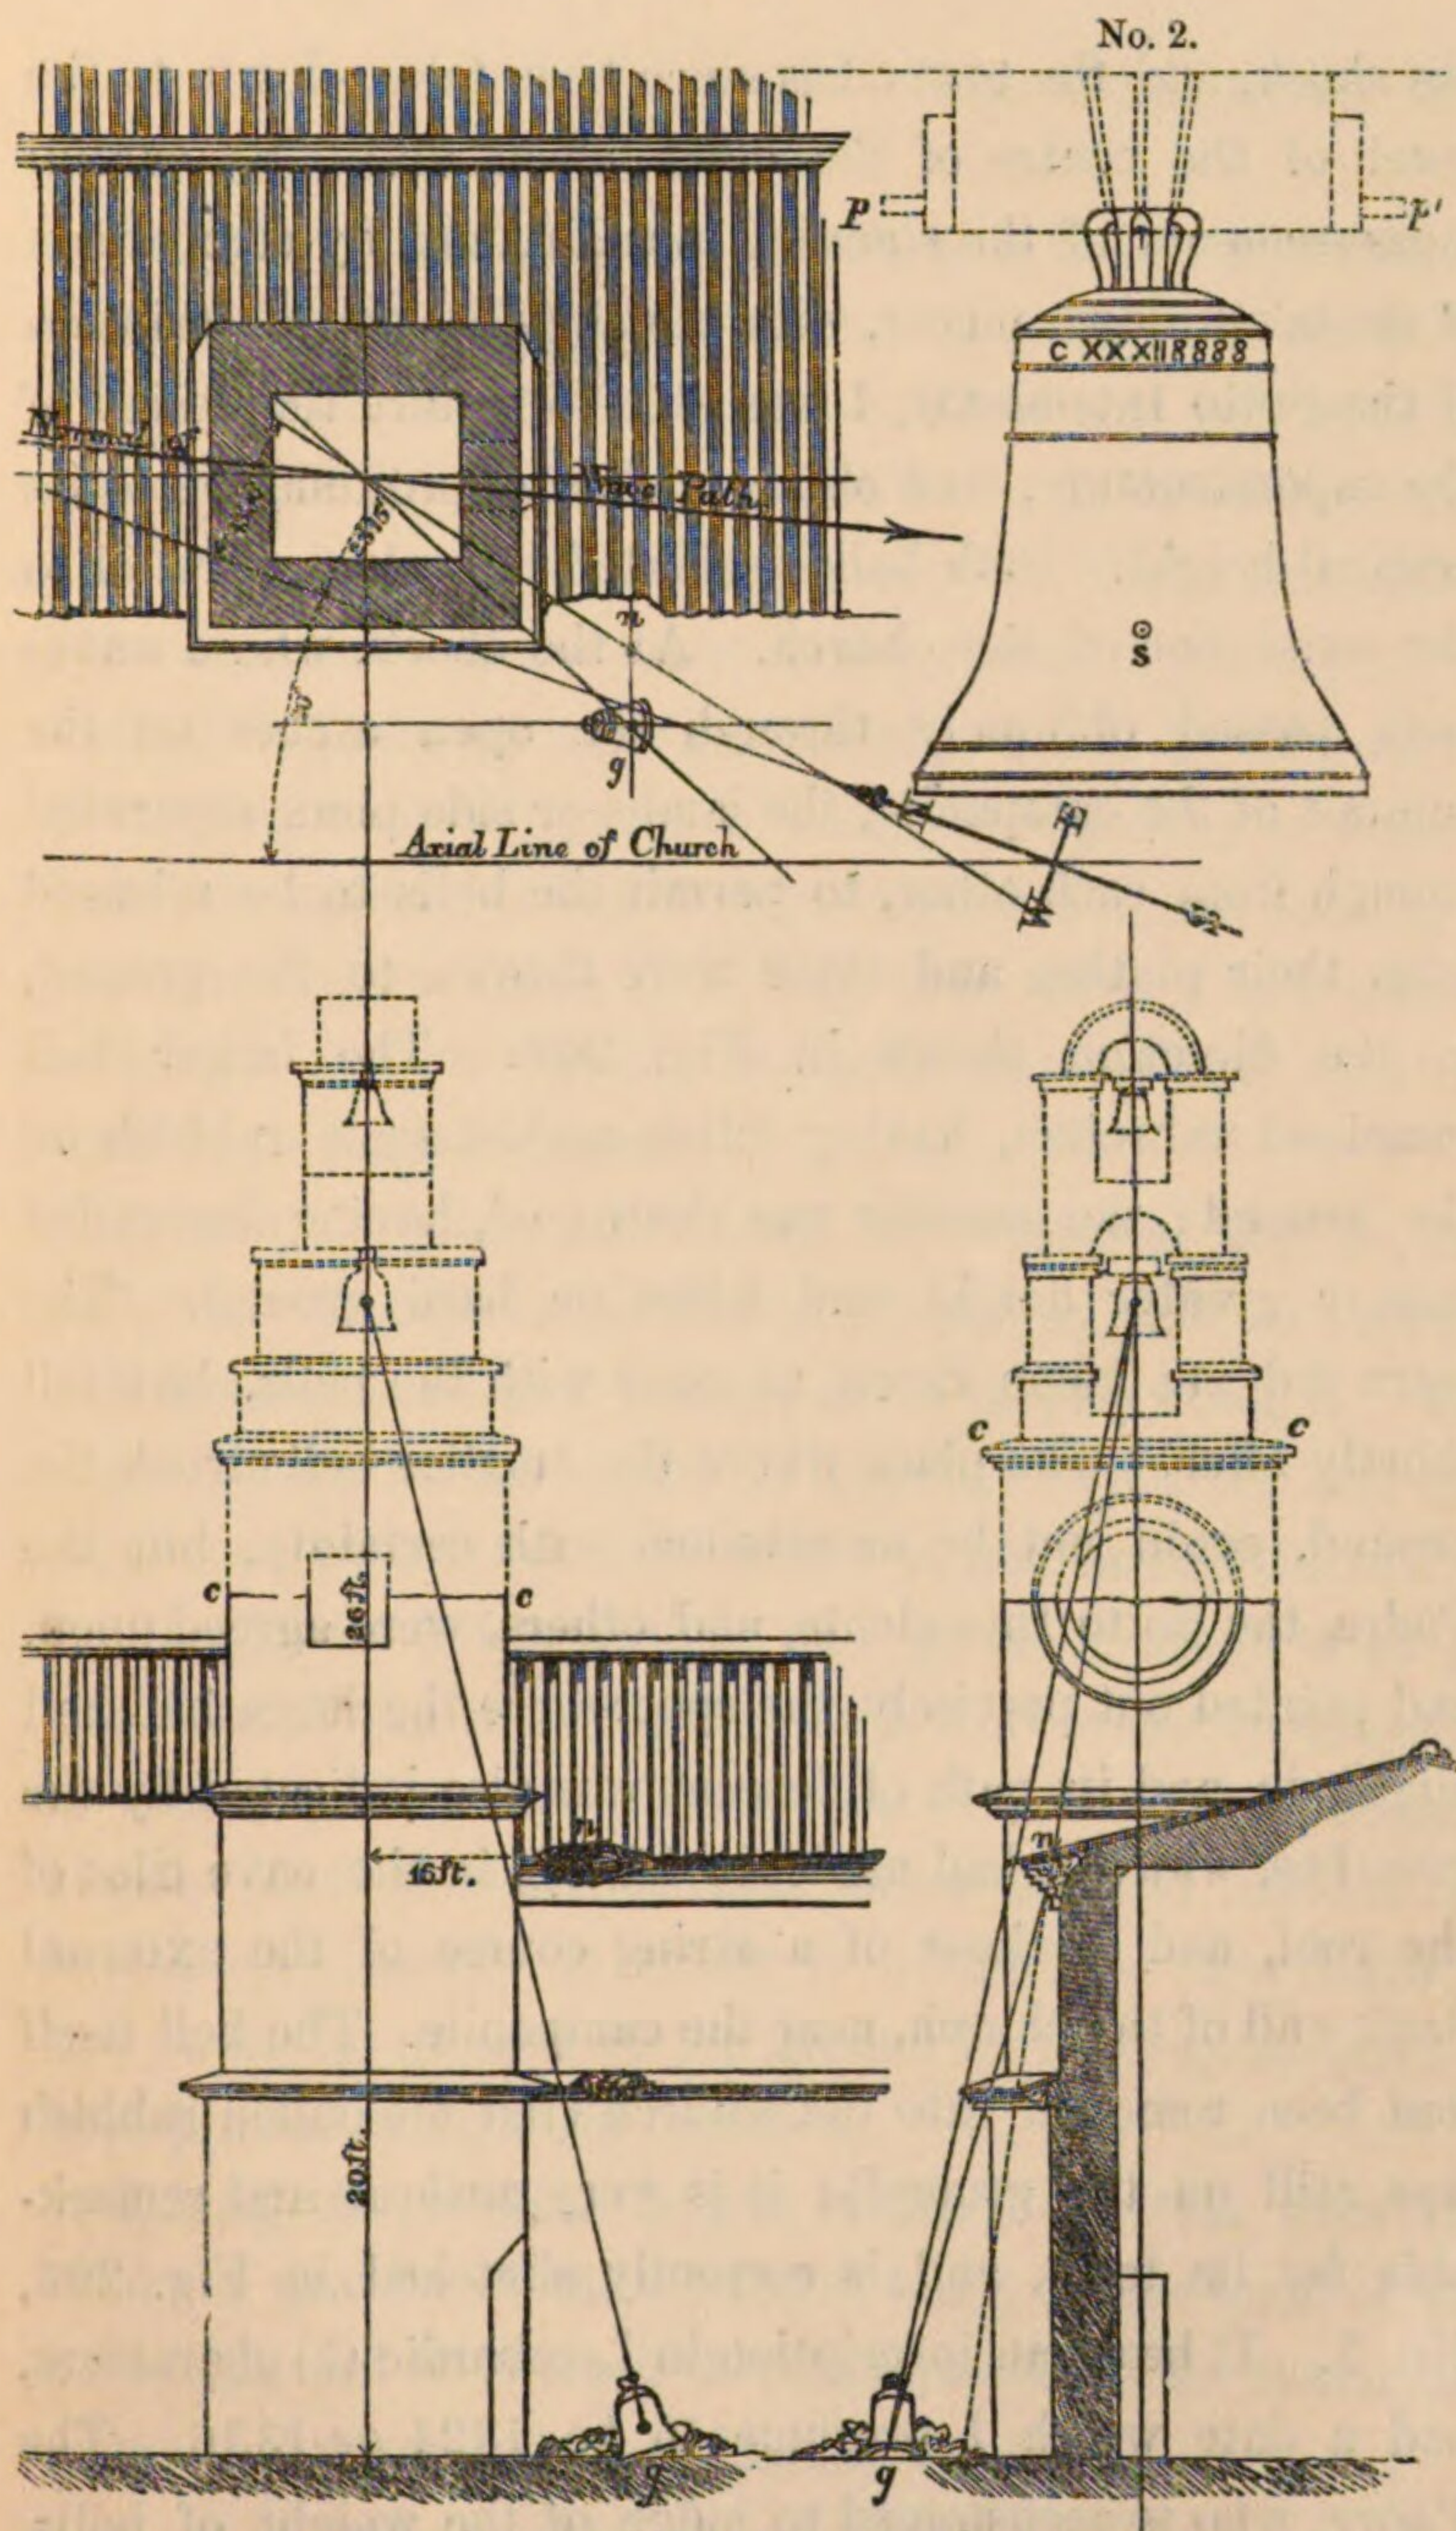
The church of La Sala, like numbers of others in Southern Italy, has been built, not in accordance with ecclesiological notions, but to suit the lie of the ground. Its axial line is 20° W. of north, and it has a campanile, rectangular in plan, external to one flank wall, as in diagram Fig. 206. The upper part of this, previous to the earthquake, carried two bells, hung between the jambs of piers and arches on top. These were overthrown, down to the level of *cc* by

the shock, and the tower has since been taken down, to the level of the centre of the mock clock dial. By careful measurements of the standing portion, and by comparison of the taken down pieces, with the sketches and description of the Sotto Intendente, I was able to restore the design of the superstructure, and obtain a close approximation to its original height. Both bells oscillated in a plane, parallel to the axial line of the church. At the shock, whose wave-path passed obliquely through the open arches on the summit of the campanile, the jambs or side piers separated enough from each other, to permit the bells to be released from their pintles, and these were thrown to the ground, in the direction shown in Fig. 206. The larger bell remained unbroken, having fallen amidst some rubbish on the ground; the smaller was destroyed, having descended from a greater height and fallen on hard ground. The piers did not come down at once with the bells, but fell shortly after. The place where the smaller bell struck the ground, could not be ascertained with certainty, but the Padre, the Sotto Intendente, and others, were agreed upon, and pointed out precisely, the spot where the large bell had alighted; and its path of descent was also indicated by the breaches, which it had made in falling, in the eave tiles of the roof, and in those of a string course of the external flank wall of the church, near the campanile. The bell itself had been removed into the church (but the fallen rubbish was still on the ground): it is very antique and remarkable for its form, and is correctly sketched in Fig. 206, No. 2. It bears an inscription in Lombardic (?) characters, and a date which I presume to be 1324 or 1336. The Padre, who is accustomed to judge of the weight of bells,

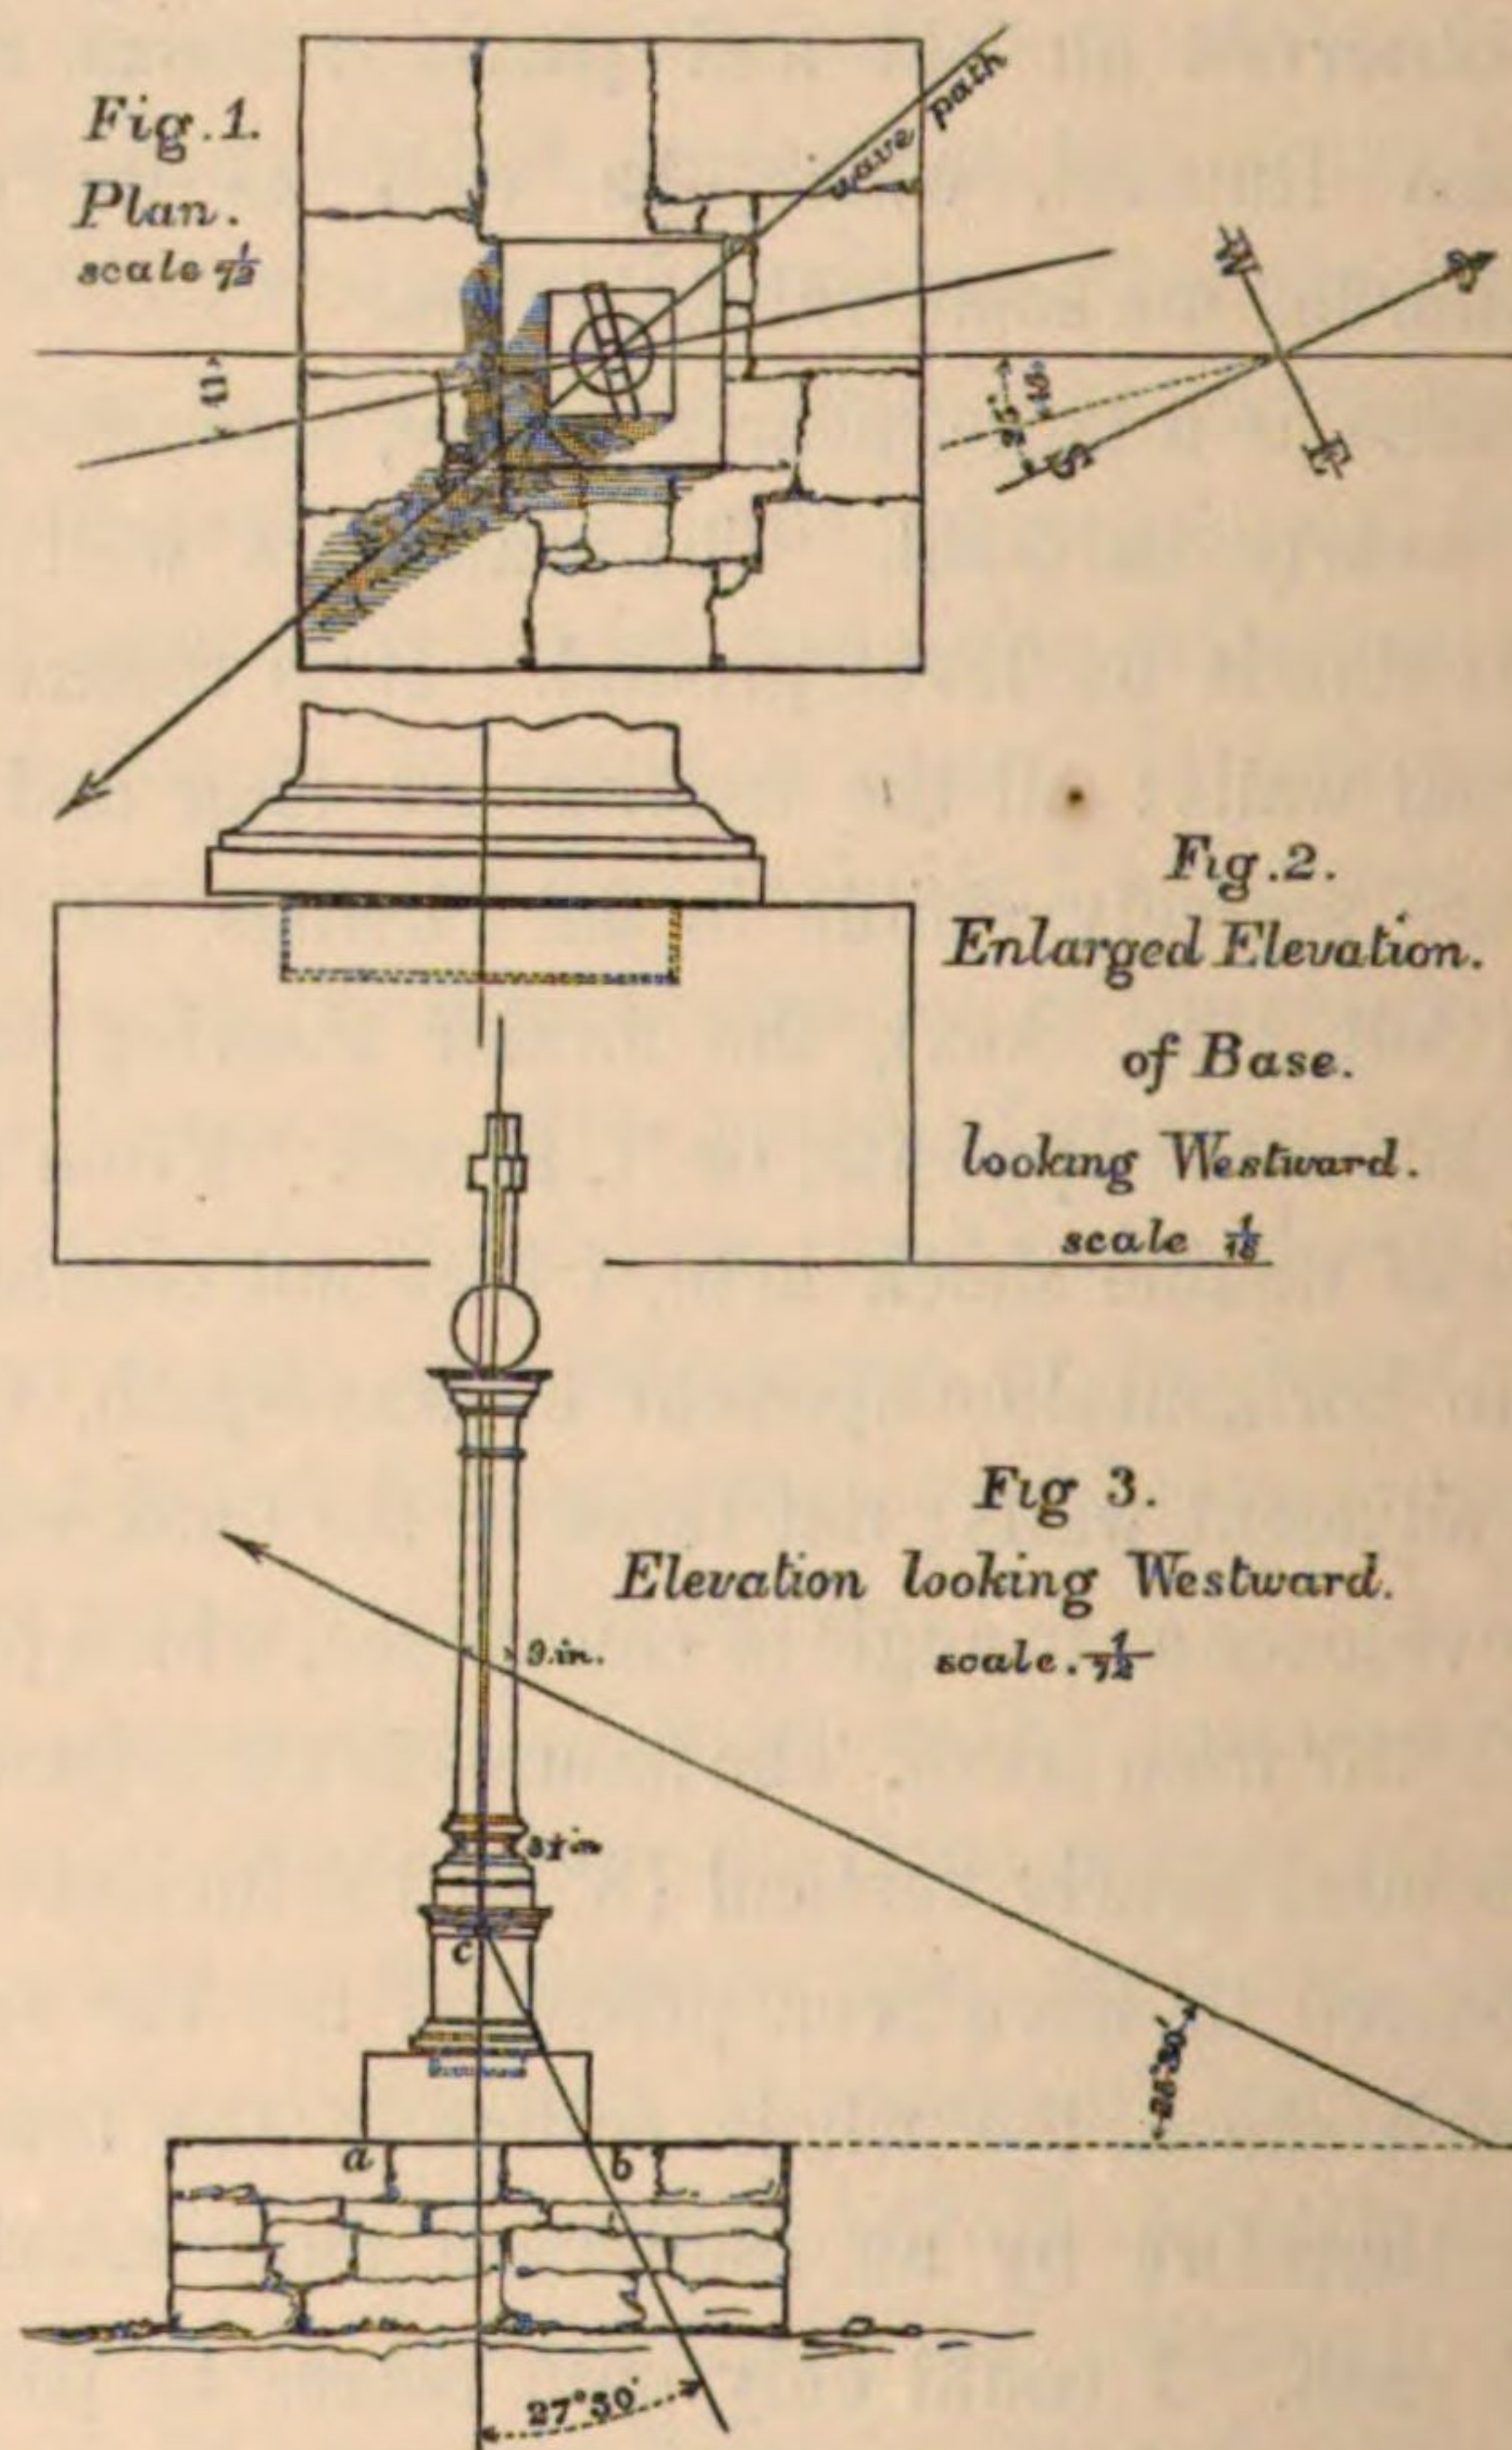
Fig. 216.

cross, and placed upon a square pedestal and plinth block, elevated on a few courses of rude masonry as in Photog. No. 215 (Coll. Roy. Soc.), and Figs. 1, 2, and 3, Diagram No. 216. The ball and cross are secured to the top of the column, only by an iron dowal, and are loose; the plane of

the cross has been long twisted out of square, I was informed.

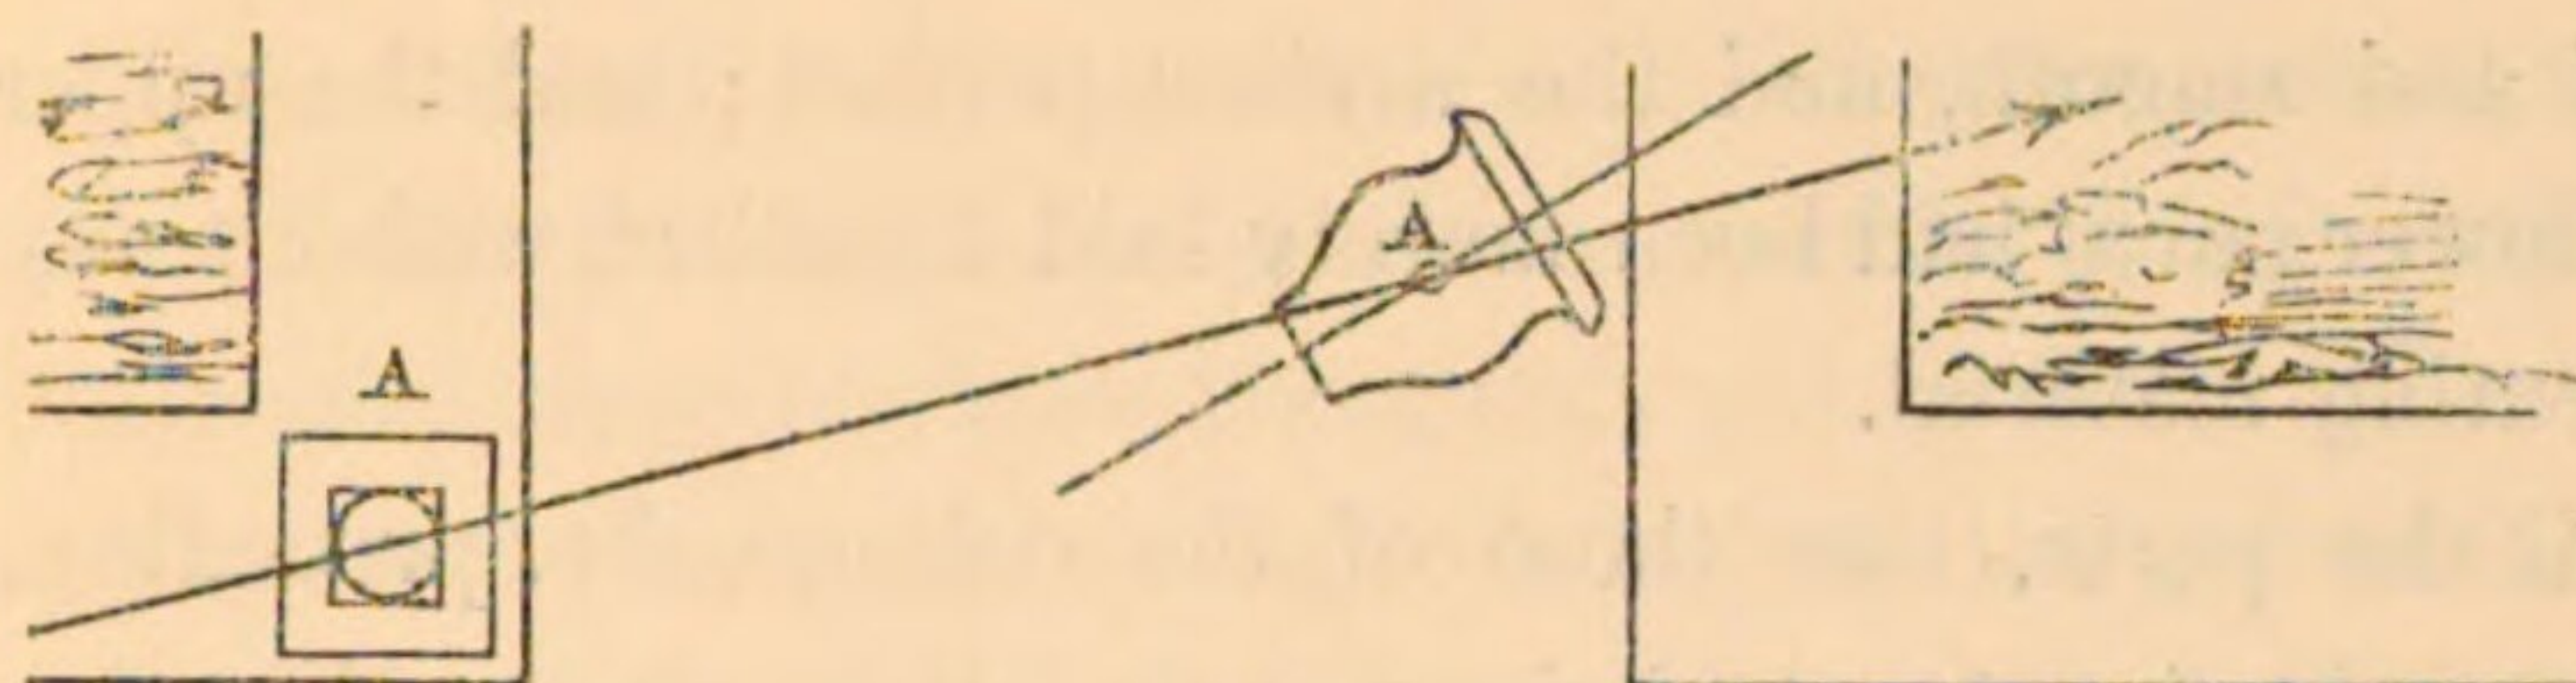
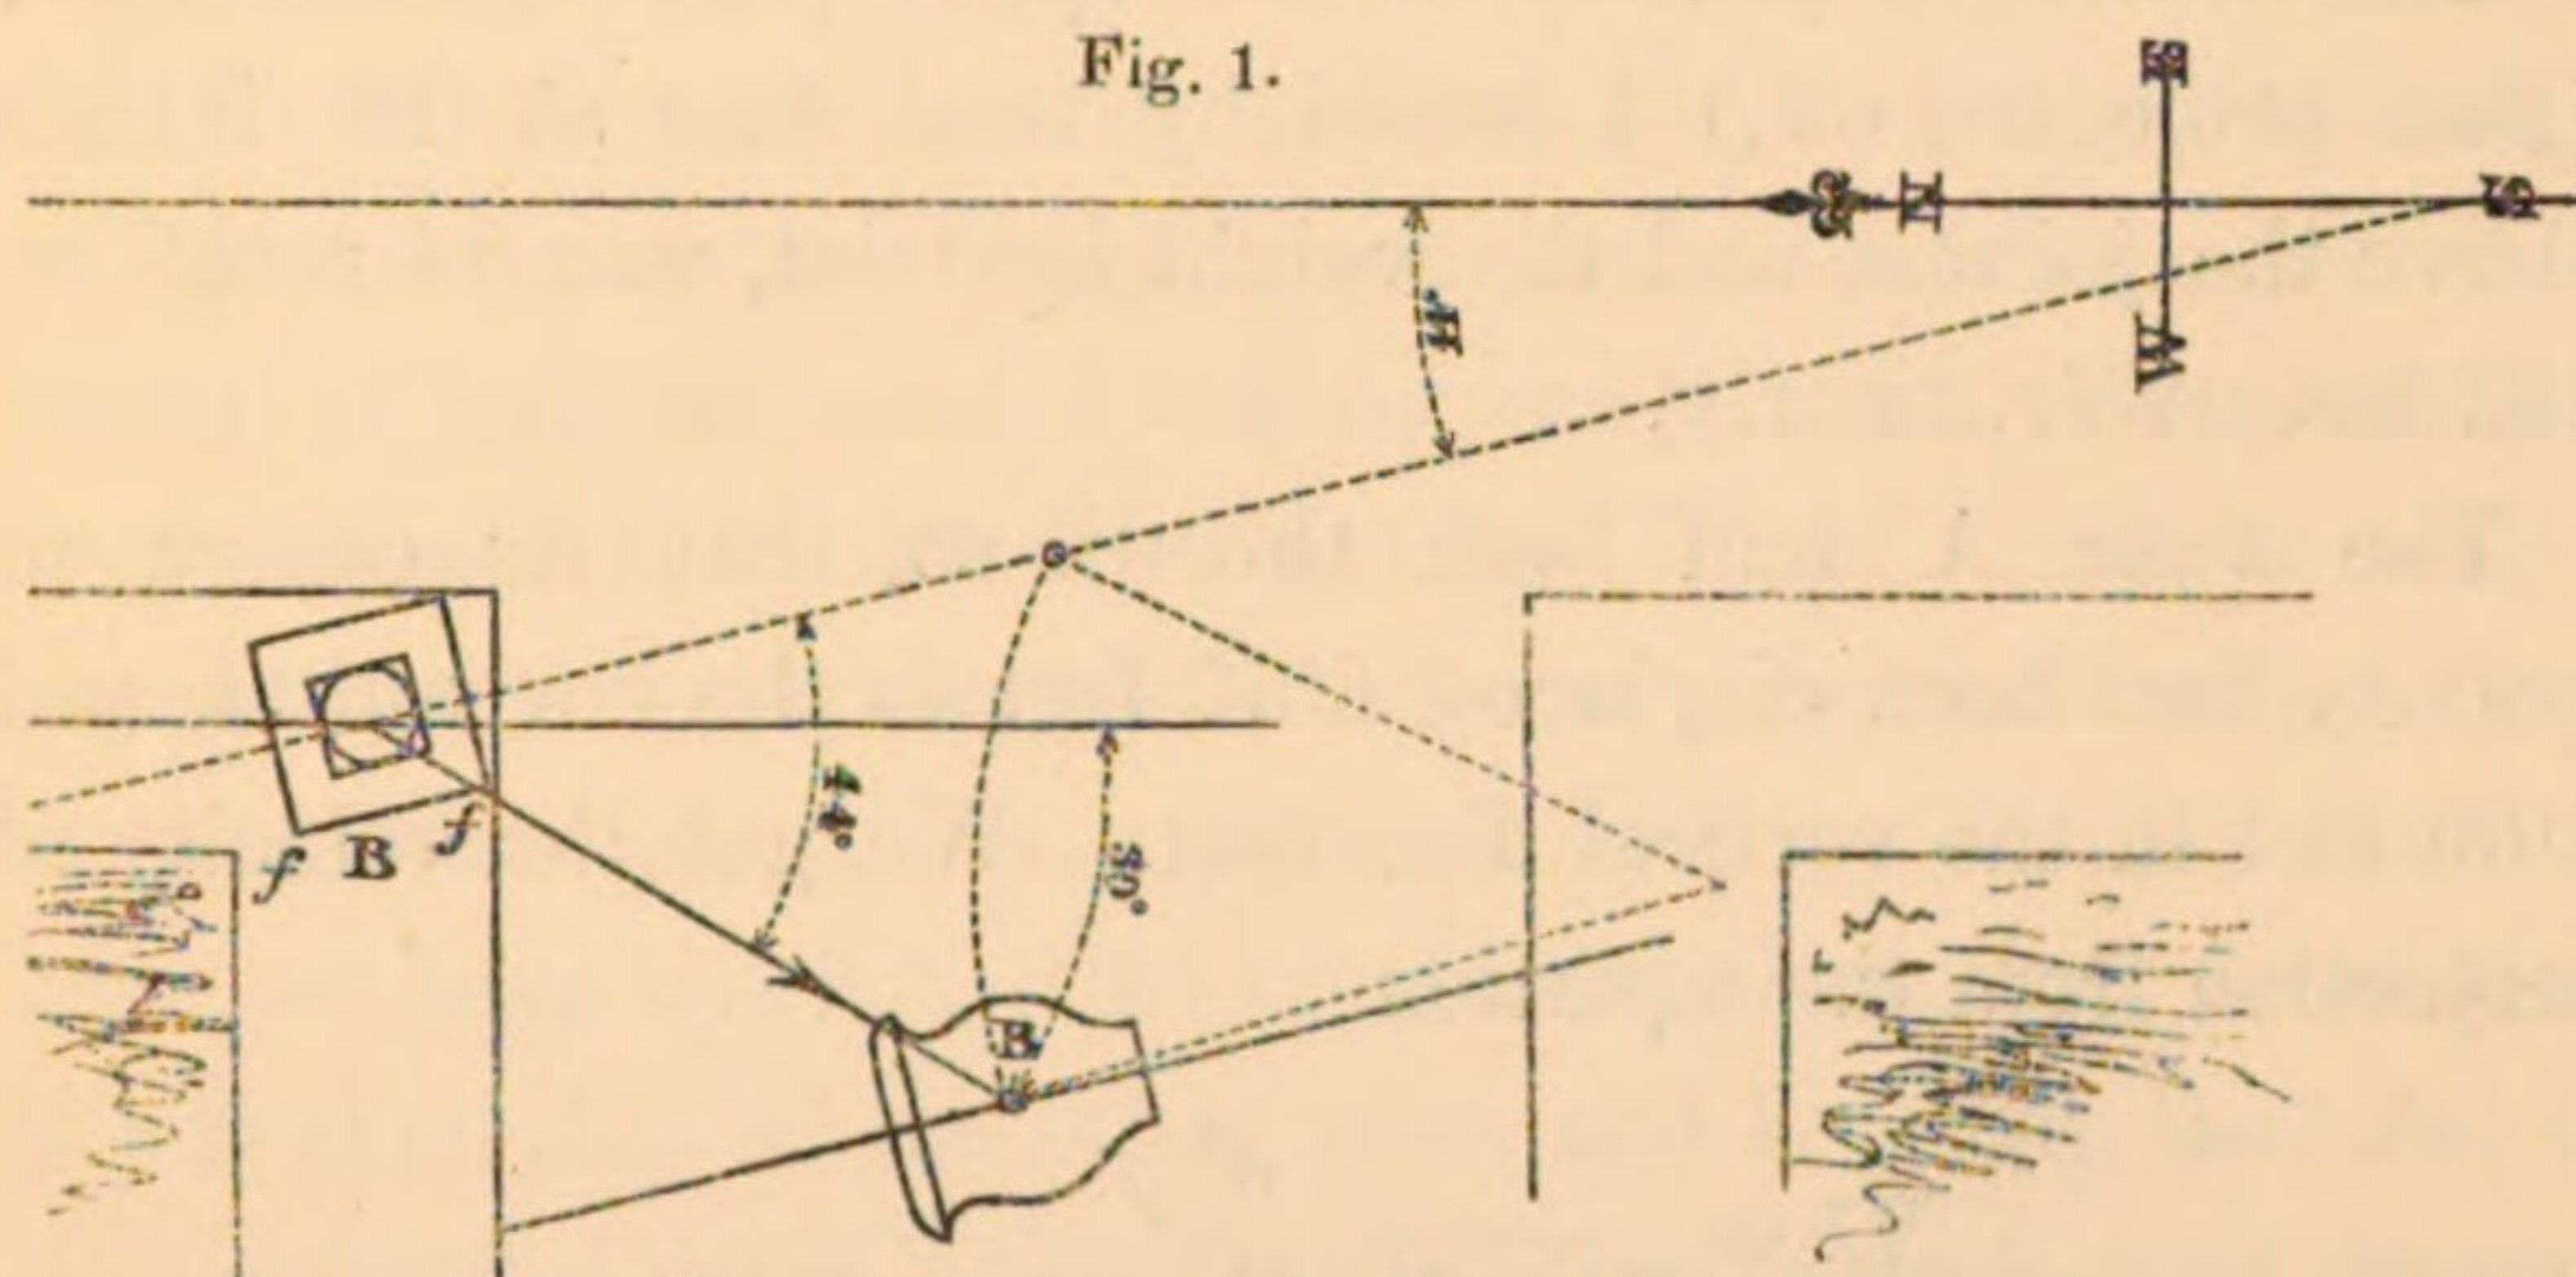
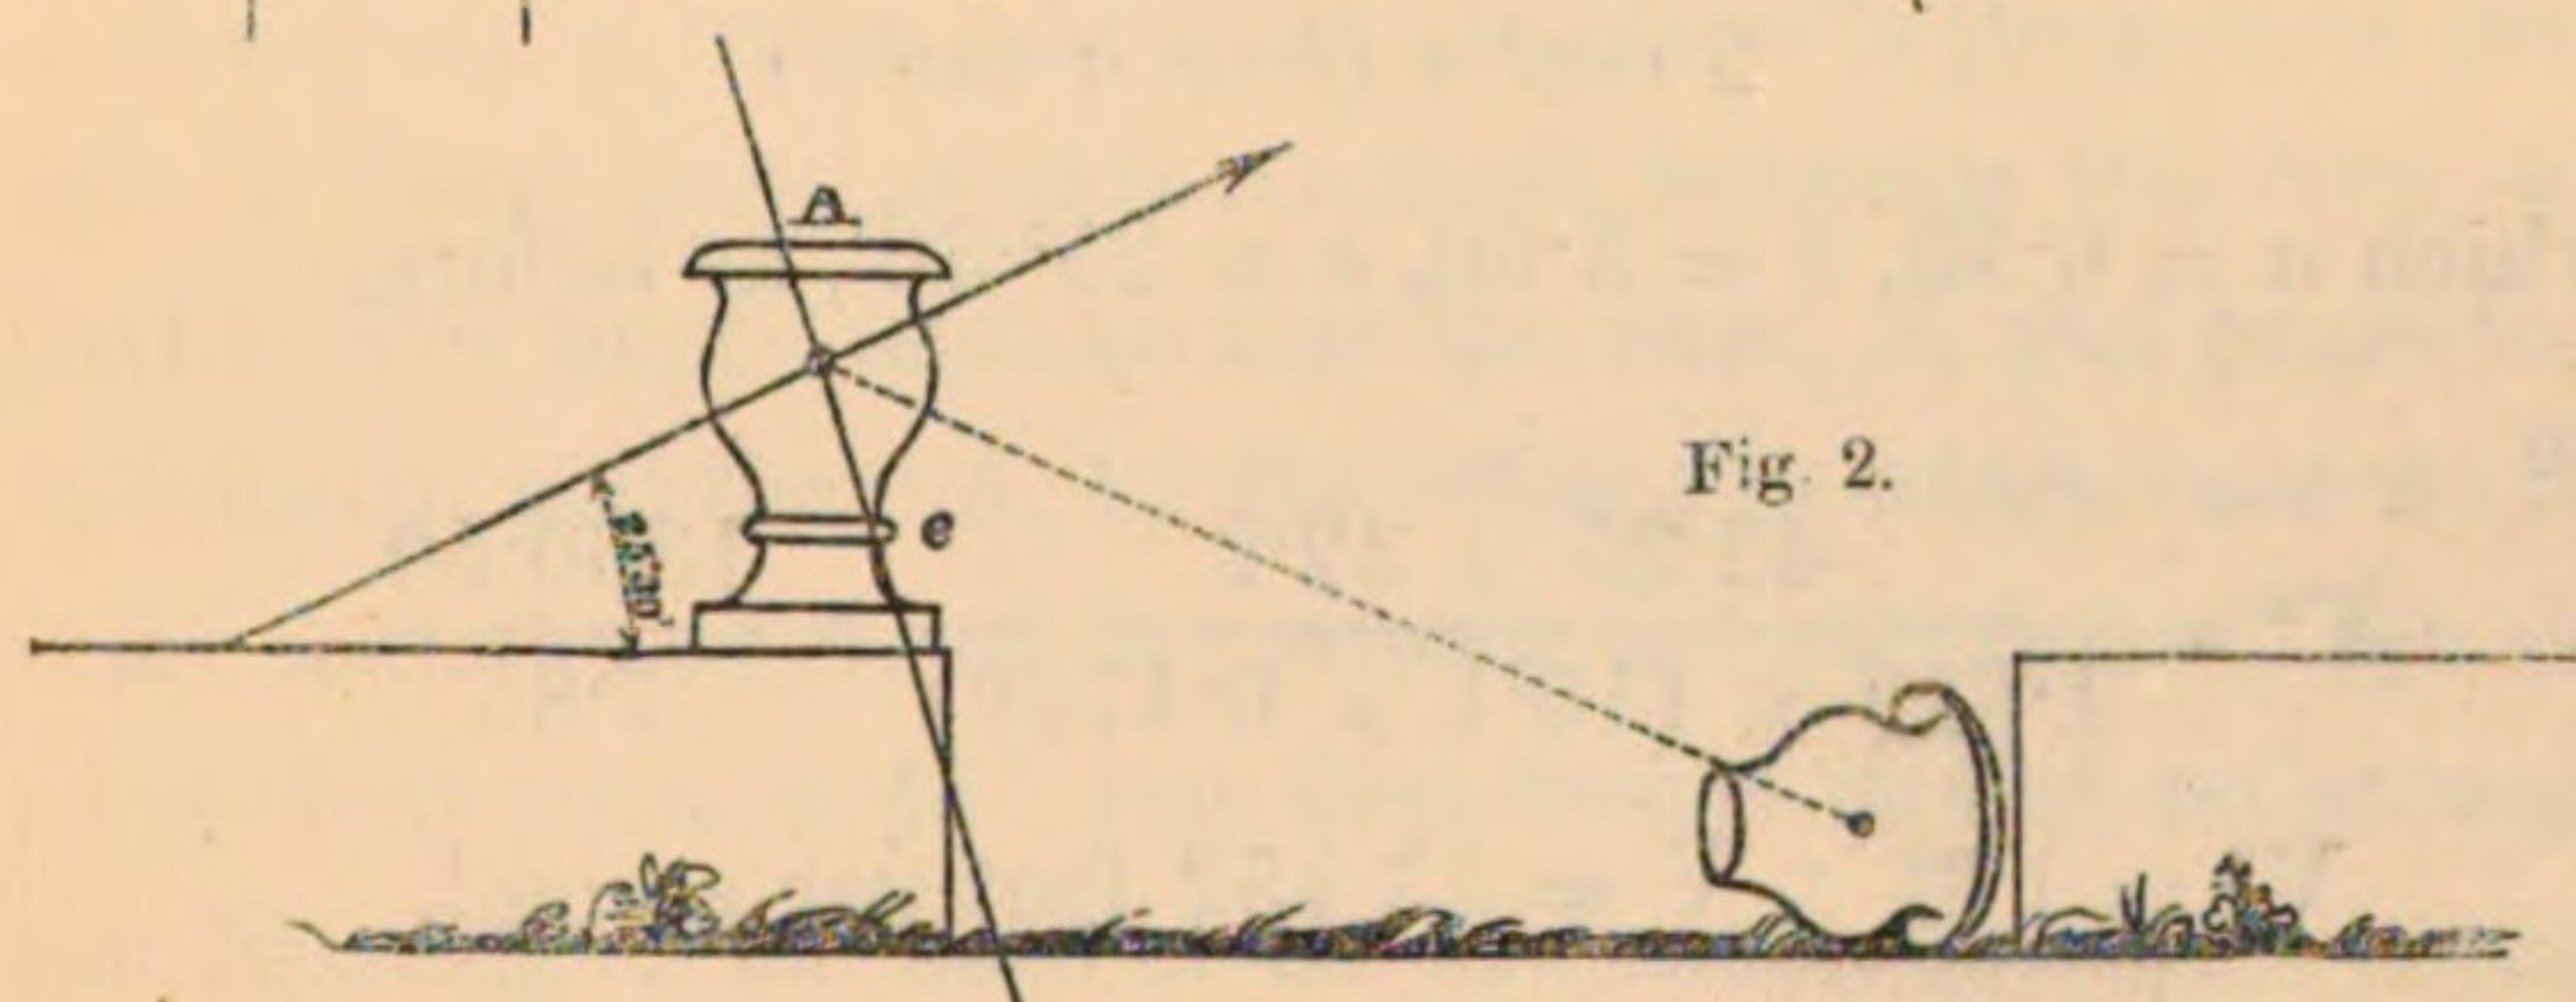
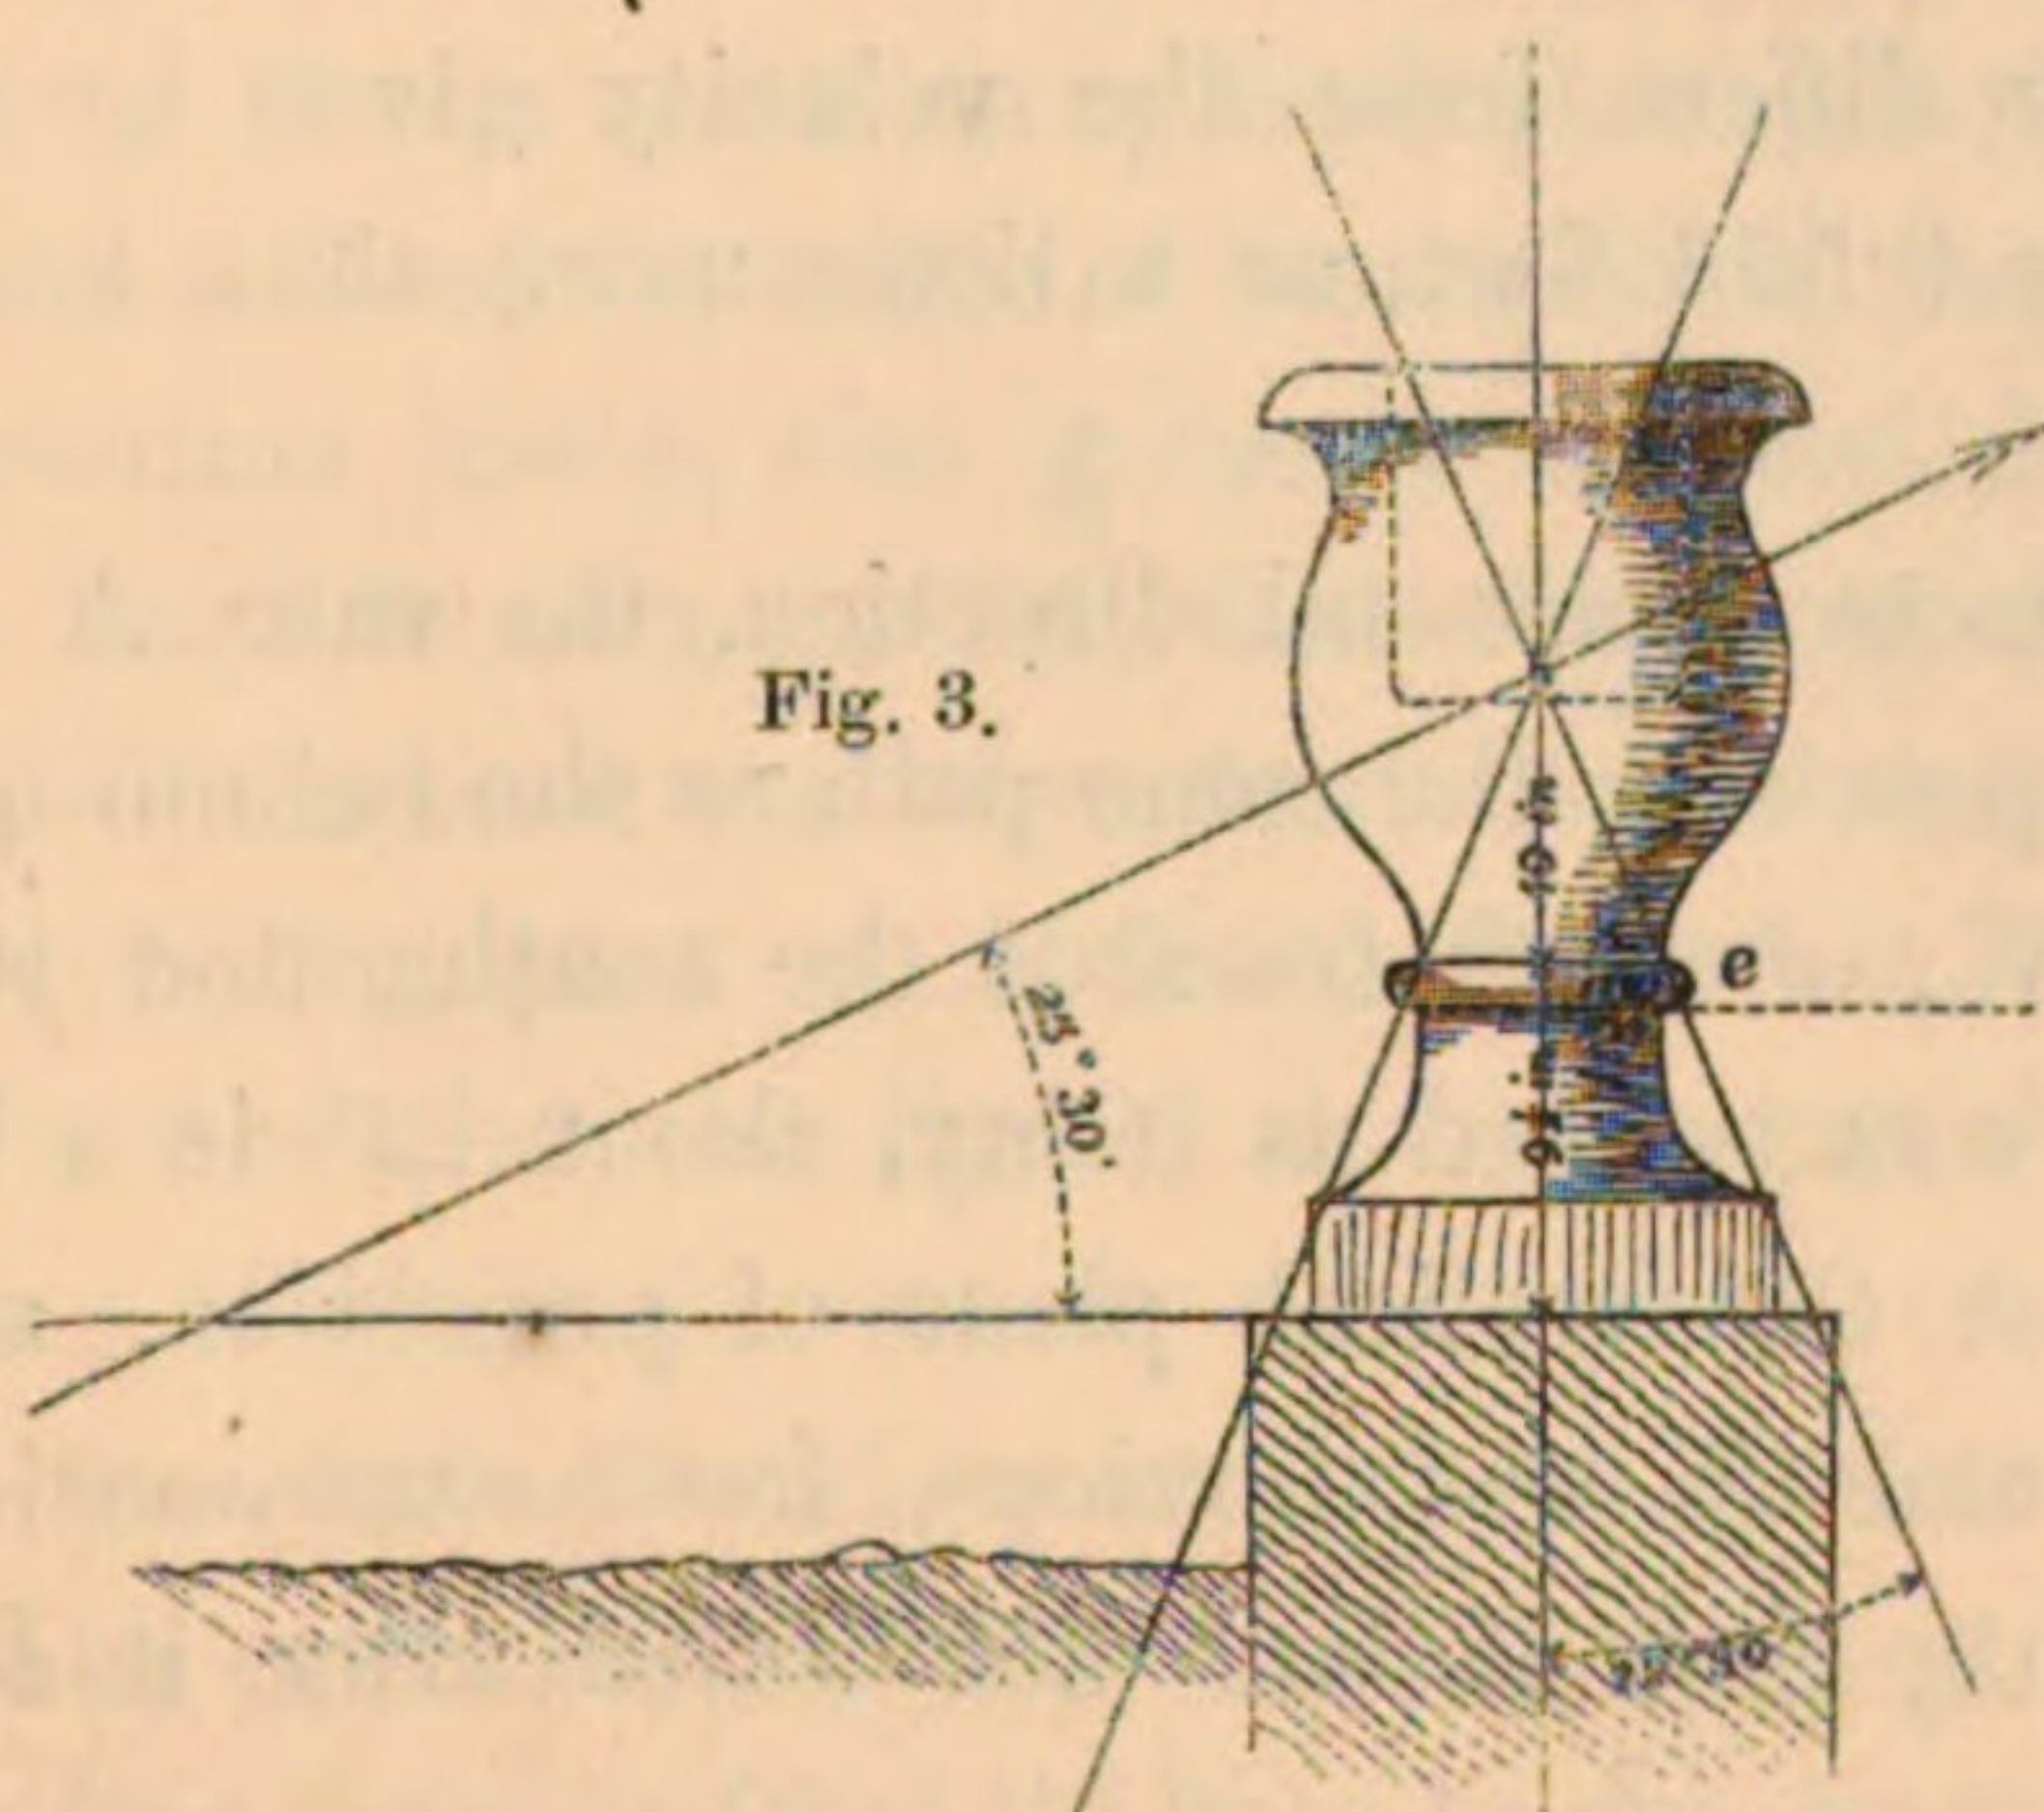
Diagram 222.

These vases were both projected off their feet or lower portions, at a joint at e , Figs. 1 and 2, Diagram No. 222, and thrown to the ground, the lower portions remaining still upon the parapets, as seen in Photog. No. 220 (Coll. Roy. Soc.). One of the lower portions, (A, Fig. 1,) I found square to the faces of the parapets, and obviously unmoved; the other, B, had been twisted round 14° , so that two of its sides were in a line exactly north and south 14° W.

The lower portions at the joint e (Figs. 1 and 3) were quite

level and smooth, and the arrises perfect; and the upper and lower parts had been merely laid together, without any cementing material.

It will be seen, on looking at Fig. 3 (Diagram No. 222), that the vase might have been thus tilted upon its own base at the joint *e*, to the extent of nearly $22^{\circ} 30'$, before it would have lost the power of recovering its position, and that when tilted through part of this angle, the effect of the throw of the second shock delivered to it through the base, would tend to increase the rotation commenced, as well as to diminish the extent of horizontal range, or velocity impressed.
